OPERATING EXPERIENCE WEEKLY SUMMARY

Office of Nuclear and Facility Safety

June 19 - June 25, 1998

Summary 98-25

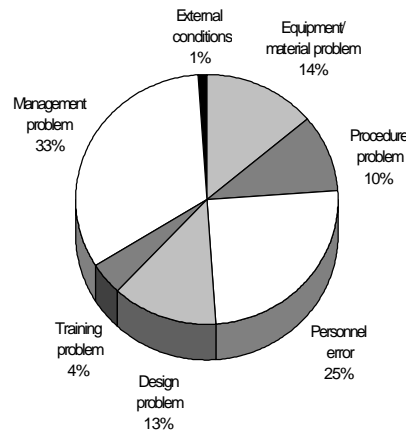
Figure 2-1. Root Causes of Hazardous Electrical Occurrences¹

OEAF engineers reviewed selected occurrences from the ORPS database from October 1, 1990, through March 31, 1998, for hazardous electrical occurrences (with the causes determined) and found 771 reports. More than half of the occurrences had a root cause of either management problem or personnel error. About 27 percent of the management problems resulted from inadequate administrative control; 25 percent resulted from inadequate policy dissemination and enforcement; and about 25 percent resulted from work-planning deficiencies. About 41 percent of the personnel errors involved inattention to detail, and 40 percent involved procedure not used or used incorrectly. Taken together, the data indicates that nearly 72 percent of all occurrences could be eliminated by a well-trained, well-managed, attentive workforce using good procedures. Figure 2-1 shows the distribution for hazardous electrical occurrences.

Managers and supervisors in charge of job performance should ensure that hazards are identified and corrected. DOE facility managers should ensure that personnel understand the basics of work control practices and safety and health hazard analyses. Personnel in charge of system design changes should ensure that facility documentation, including procedures and drawings, is updated and accurate.
